Within TEXMIN project, an application in pilot scale the remedial measures for stabilization of mine spoil dump in situation of extreme weather events occurrence, has been planned.

The Janina Mine spoil heap (waste disposal facility) in Libiqż (PL) was selected as the site for the pilot study. In recent years, under the pressure of a growing waste heap, especially after intensive rain, landslides have been repeatedly observed here, which poses a threat for the surrounding residents. Hence the need to secure and then revitalize the site.

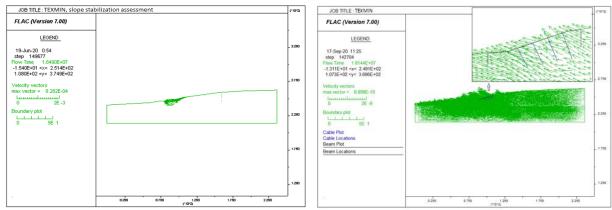
A numerical model was developed to determine the boundary conditions and technical parameters necessary to effectively increase the stability of the facility in changing weather. The numerical modelling results indicate the loss of slope stability under the impact of high rainfall intensity (figure on the left) value of velocity is higher than permissible value (1e-5), while slope is considered stable in case of using selected reinforcement (figure on the right) – value of velocity is much lower than the permissible value.

Velocity vectors of slope model: without any preservation (left) and with preservation using nailing and steel mesh (right)

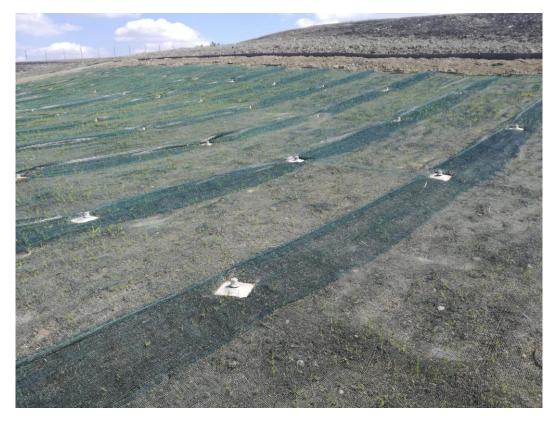
After nailing has been completed, facing has been conducted, consisting of anti-erosion protection and steel mesh.

Additionally, water drainage has been included in order to drain water into a circular ditch. The form of a ditch has been made of meliorative concrete channels.

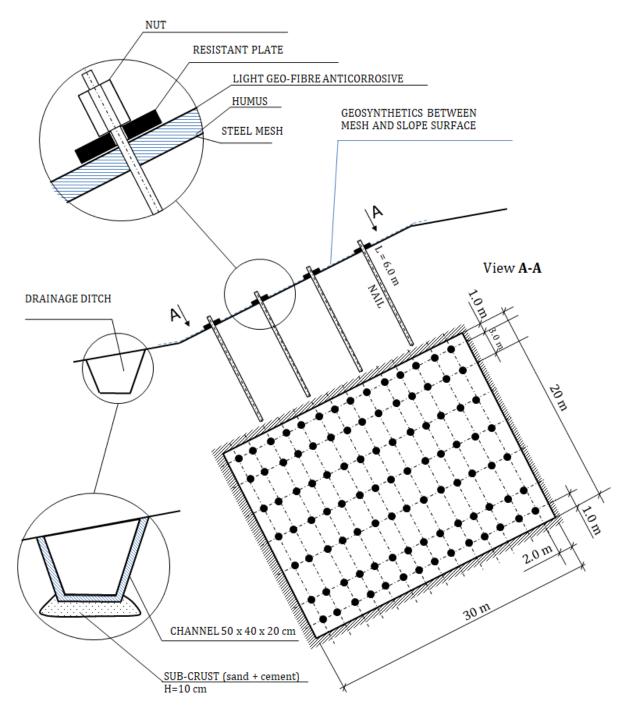
At the figure below, a scheme of the reinforcement is presented.

Scheme of slope preservation of the mine waste dumps against the impact of extreme weather events at the Janina mine site in Libiqż

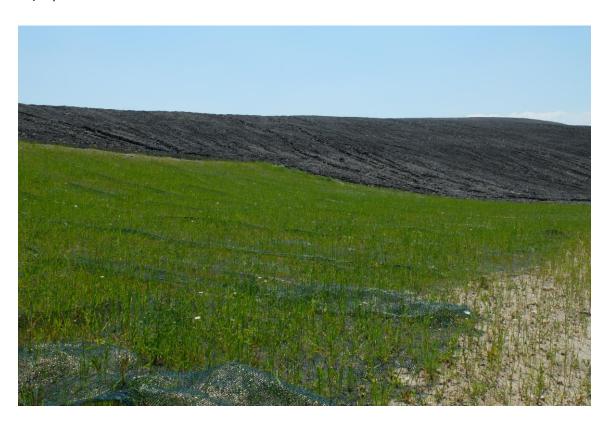
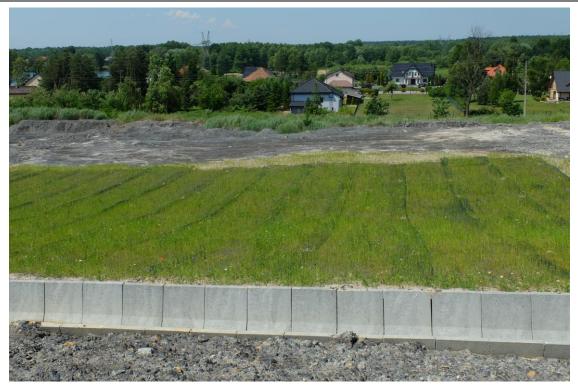
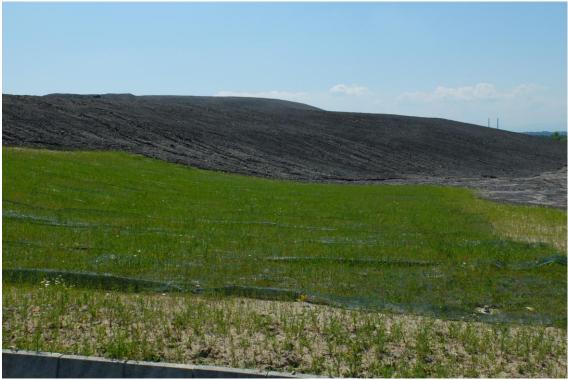
- a) creating a layer of fertile soil on the slope by humusing,
- b) sowing the fertile soil layer with grass seed compositions in the amount from 18 g/m 2 to 30 g/m 2 , selected according to the habitat conditions.

This step started early spring 2021. Photo documentation of on-going results (status at mid-June 2021) is presented below.

The process of strengthening the surface by sowing grass seeds has consisted of:
