# Identification and analysis of climatic conditions affecting the mining industry - short summary and chosen examples

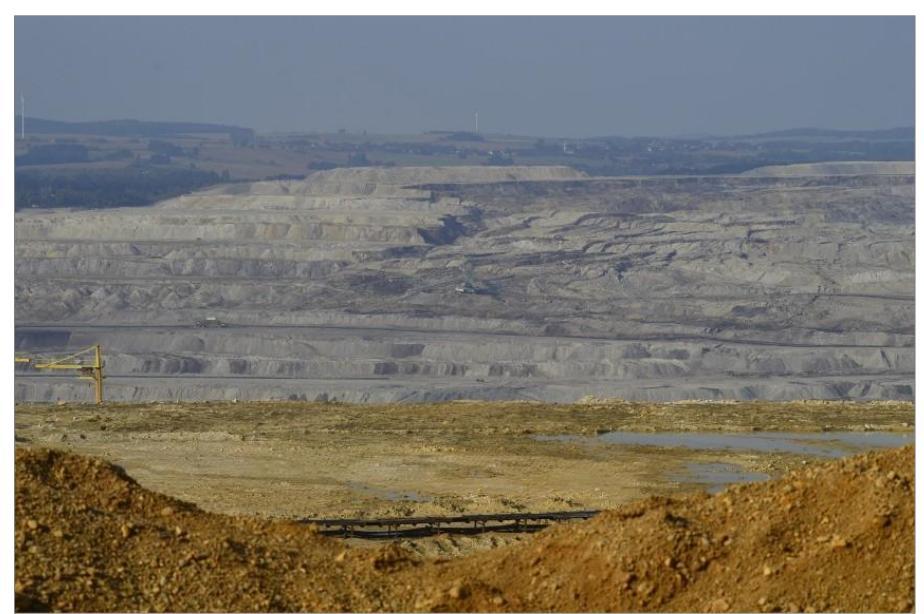
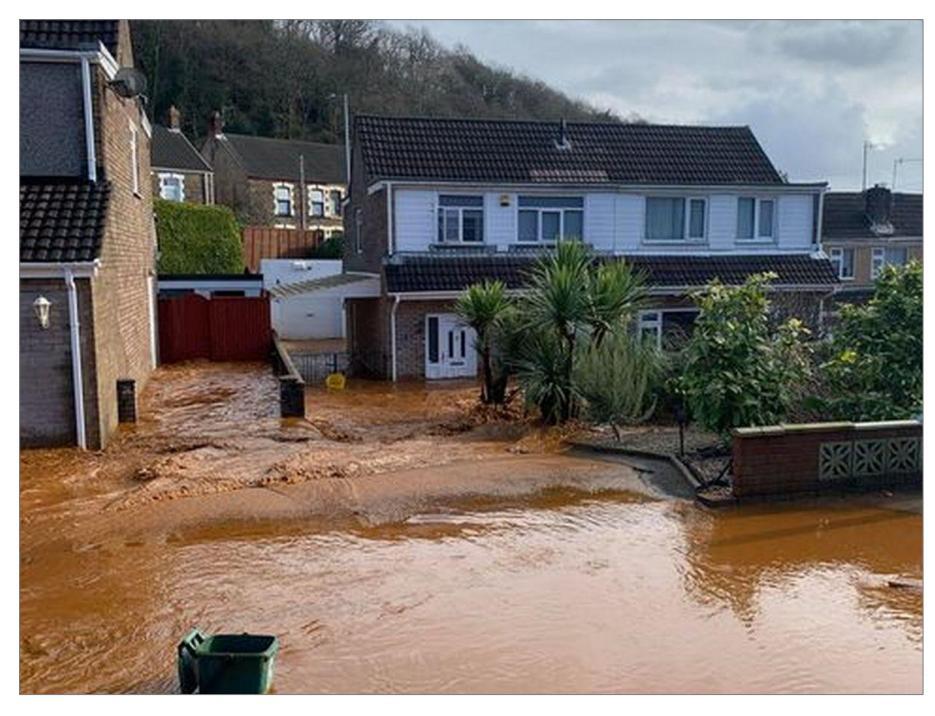
Figure 3 – Skewen, South Wales UK. Mine water inrush after Storm Cristoph,2021

Large parts of Wales (UK) were affected by flooding after Storm Christoph brought heavy rain. On 21 January 2021, following Storm Christoph and prolonged wet weather across Wales a large volume of water flooded into Skewen from mine workings in Goshen Park.

Authorities have been investigating the case and the early indications are that it is linked to a disused mine in the area (Skewen mine) the potential of a "burst mineshaft" being the cause.

High levels of iron in water from abandoned underground mine was the indicator of direct relation of high precipitation and mine water inrush from old coal mine. As a result of this event, it is planned to build a new

mine water management system to capture the water coming down from the mines above Skewen to reduce the risk of such an event happening again.

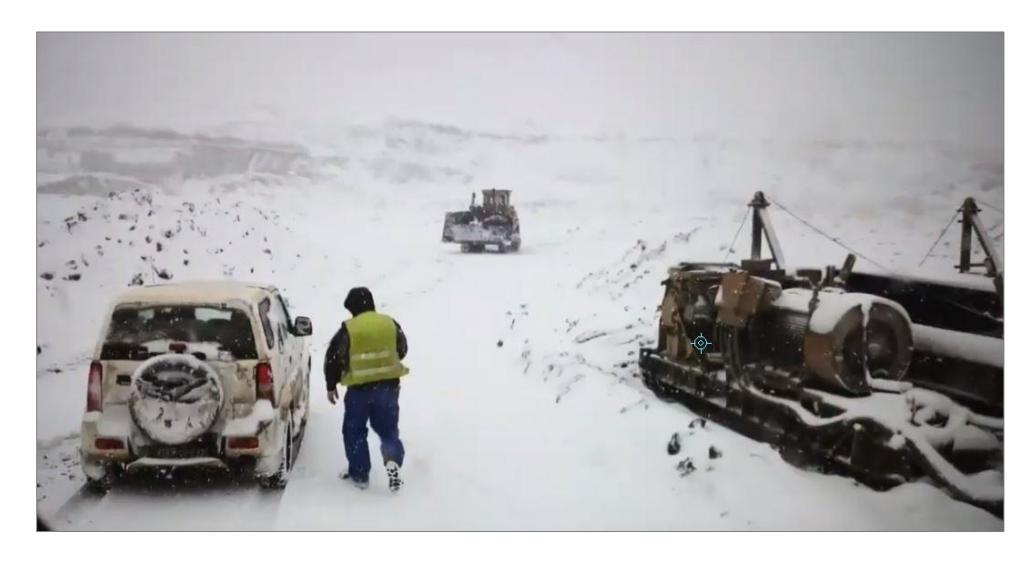
Figure 4 – Western Macedonia Lignite Centre: Heavy Snow Events Winter 2002-2003

Also in Greece, the principal cause for mining-affecting incidents was extreme precipitation – specifically extreme rainfall or snowfall. The winter of 2002-2003 was characterized as the most severe winter of the last 50 years in Greece. The snowfall was too high and it led to the closure of the Western Macedonia lignite mine for 20 days. During this time, lignite extraction was impossible. This resulted in increased energy costs for Greece, and the country faced the threat of the loss of energy supply.

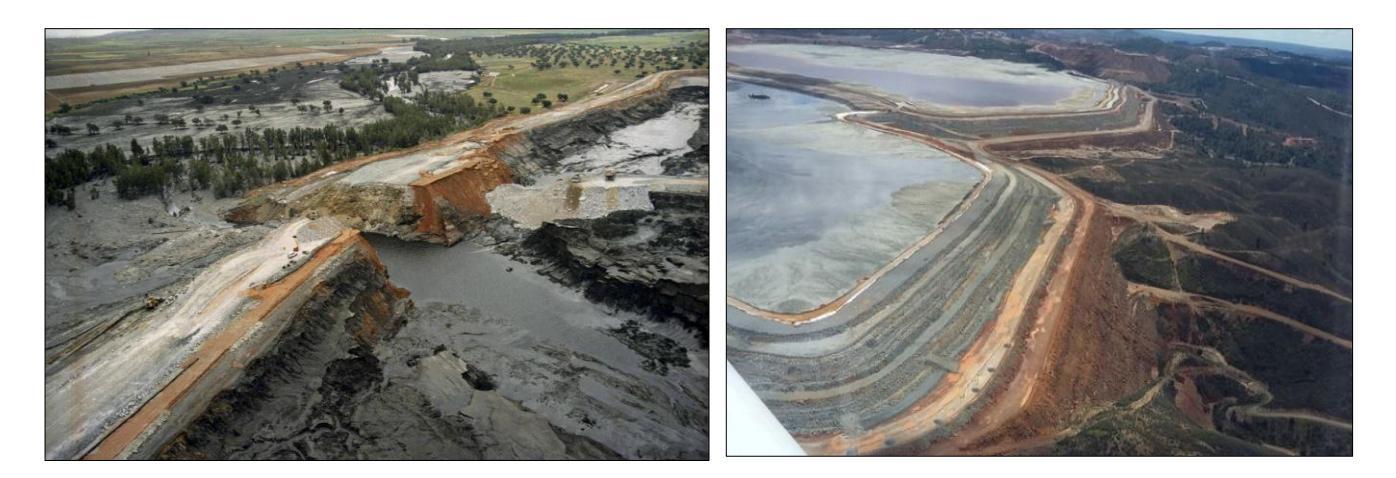
Figure 5 – Aznalcóllar Disaster of 1998

Regarding the relationship between rainfall and the effects on mining activity, no specific cases have been found in Spain, as there is a lack of formal information regarding the mines affected by heavy rainfall. However, a series of conclusions and hypotheses of the possible effects that mining activity has suffered with respect to extreme weather events can be established. The most prominent case is the Aznalcóllar disaster in 1998, where there was a breakage of the dam due to a technical failure, and the flow released affected the raft of the Aznalcóllar mine resulting in large leaks of contaminating sludge and heavy metals, producing a catastrophic environmental impact.

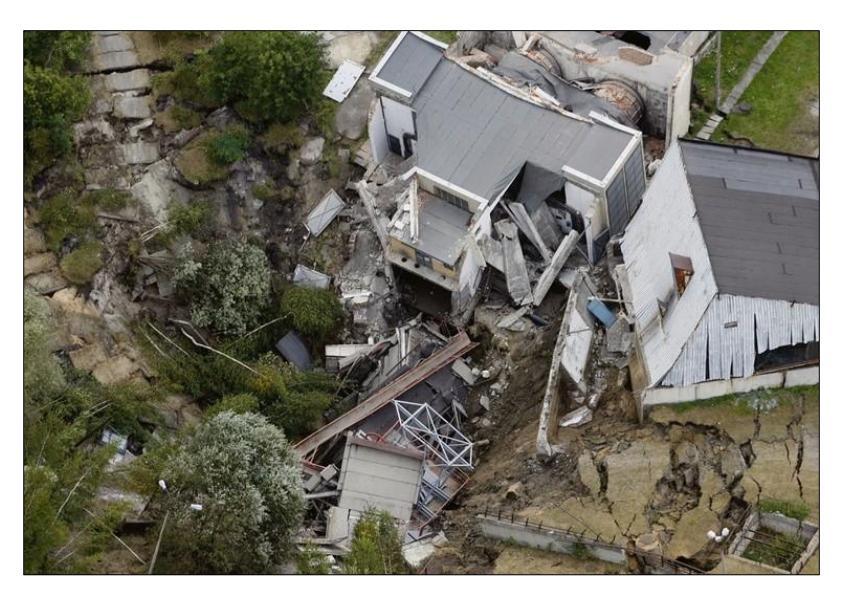
Figure 6 – Shaft Collapse – Szczygłowice Coal Mine

A shaft collapse at the Szczygłowice coal mine in the western part of GZW, Poland took place on 4<sup>th</sup> of September 2008. It was a severe mining event which was investigated and identified as a building catastrophe. Construction of the shaft tower and buildings were in very poor condition, and the stability of the surface was never investigated in relation to climate and weather events.

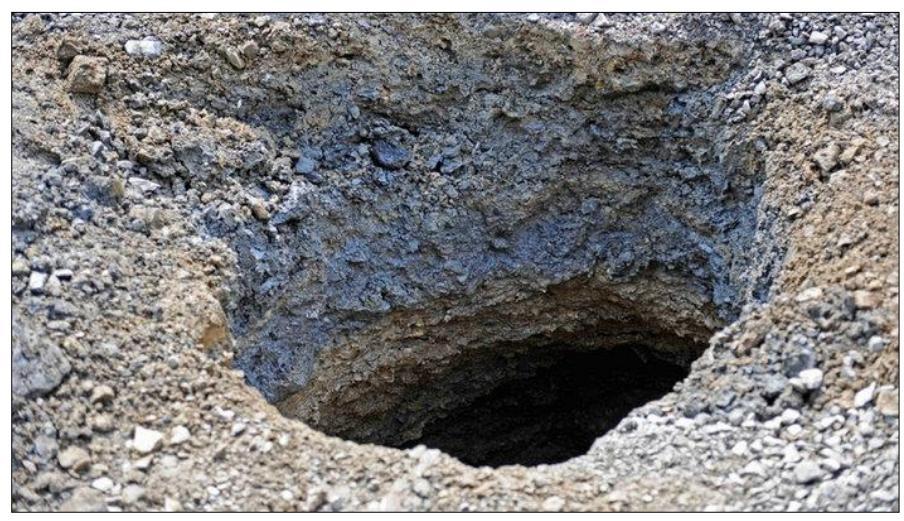
Figure 7 – Deep hole over the old shaft

In July 2009, after heavy rainfall, an 11m deep hole with a diameter of 1. 5ms was suddenly created on motorway 45 between Olpe and Freudenberg (DE), caused by the collapse of a former mining shaft from 1909. An estimated 70 to 100 cubic meters of concrete were needed to fill the hole.
